Spot Safety Project Evaluation

Spot Safety Project # 04-95-282

Spot Safety Project Evaluation of the Traffic Signal Installation at NC 42 and SR 1525 in Johnston County

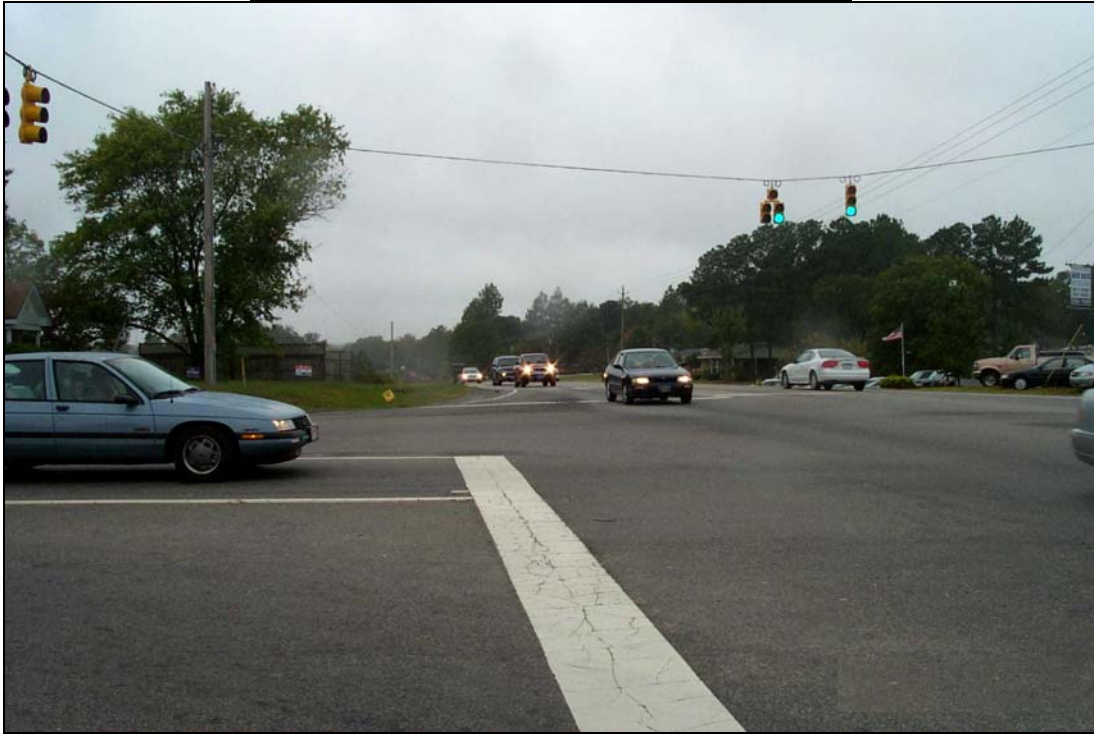
On NC 42 facing west.

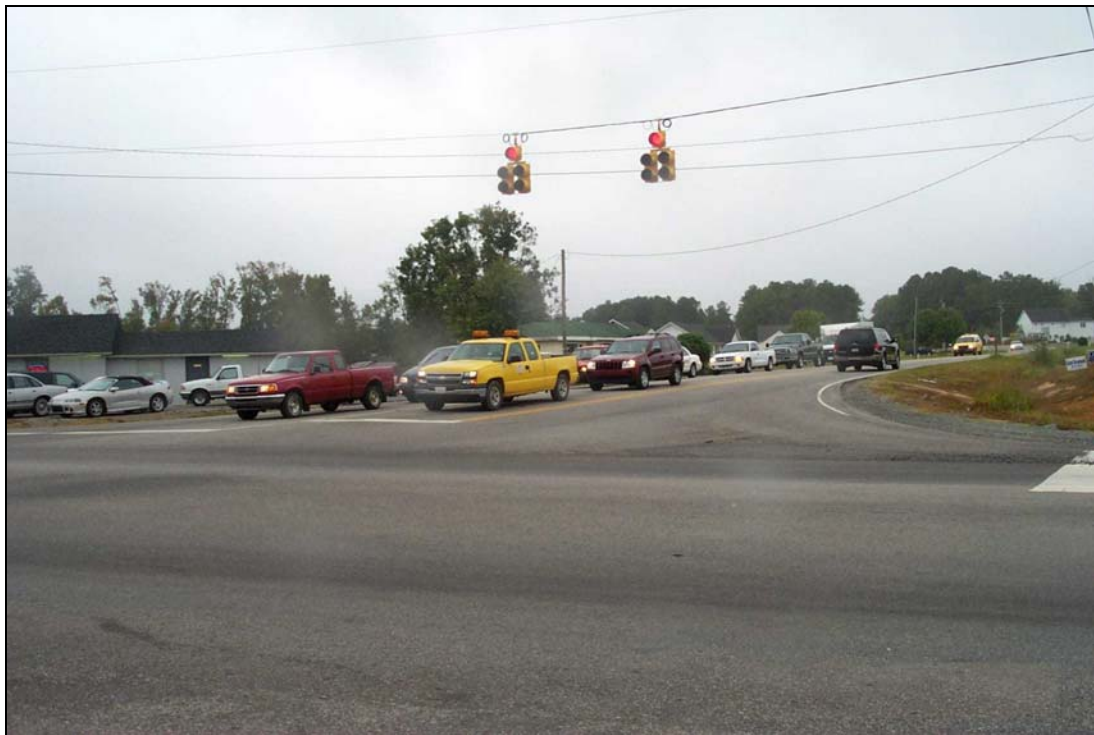
On SR 1525 facing north.

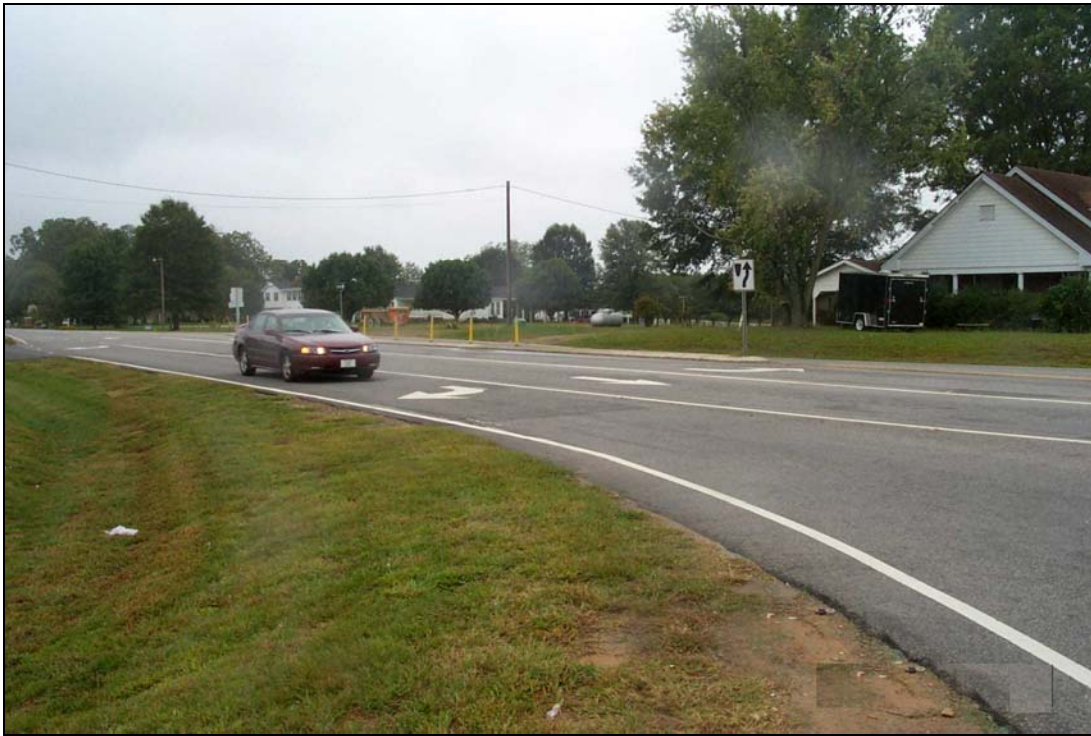
On SR 1525 facing south.

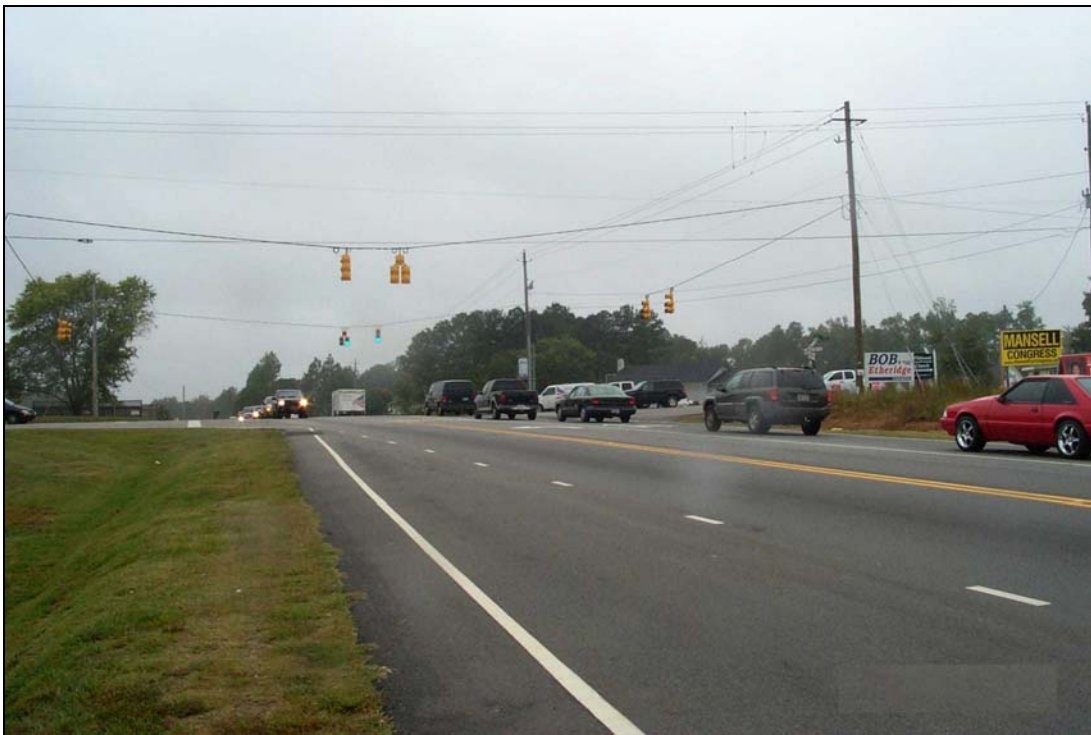
On NC 42 facing west

During the site visit a crest vertical curve was noted at the subject intersection. The steepest approach is the west leg of NC 42 at +3% toward the intersection. The east leg of NC 42 also has a decreasing slope (-2%) away from the intersection. Referencing the After Period collision diagram, the impact of the vertical crest curve can be seen by the pattern of rear end crashes. The vertical crest along with the significant increase in ADT may still be areas of concern at this intersection.

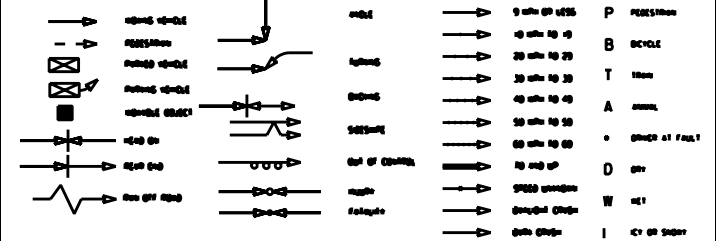
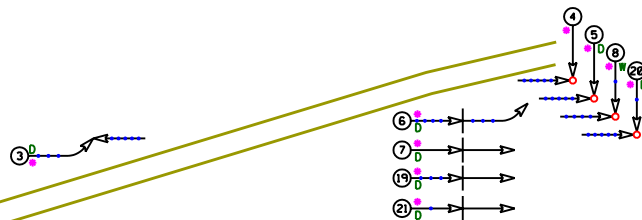
Johnston County
Treatment Site - Total Crashes
Before Period
December 1, 1990 - July 31, 1998
(7 years 8 months)

Vehicle ran off road attempting to avoid a crossing vehicle.

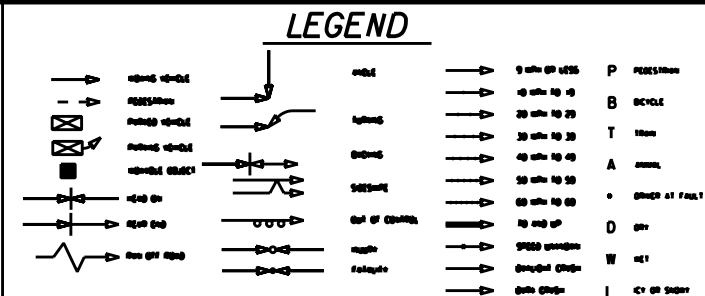
Signalized Intersection

ORIGIN:	AREA:
		STUDY PERIOD: 04/09/99 TO 6/30/99	
		DISTANCE:	T-MILE: 00 FT
		MILEAGE PREPARED BY: S. COVINO	
		PROGRAM PREPARED BY: S. COVINO	
		PROGRAM REVIEWED BY:	
SAFETY EVALUATION		TRAFFIC SAFETY	
----- AFTER TRAFFIC SIGNAL INSTALL		SCALE: NOT TO SCALE DATE: AUGUST 2000 (S. NUMBER) (PAGE NUMBER)
